At the request of the School District of Erin, CESA 10 technical experts performed a detailed on-site audit of its facilities. This audit provides the District with a comprehensive facilities maintenance and capital project plan, with identified problems, proposed solutions, and estimated costs. The recommendations in this report aim to improve failing and inefficient equipment, systems, and facilities and reduce energy consumption to ensure any taxpayer investment is managed within an appropriate payback period.

Conducted for the School District of Erin

October 25, 2024

Erin School District			
Year Built	1958		
Building Addition	1965, 1970, 1979, 1992		
Square Footage	62,900		
Annual Electric Usage (kWh)	217,141

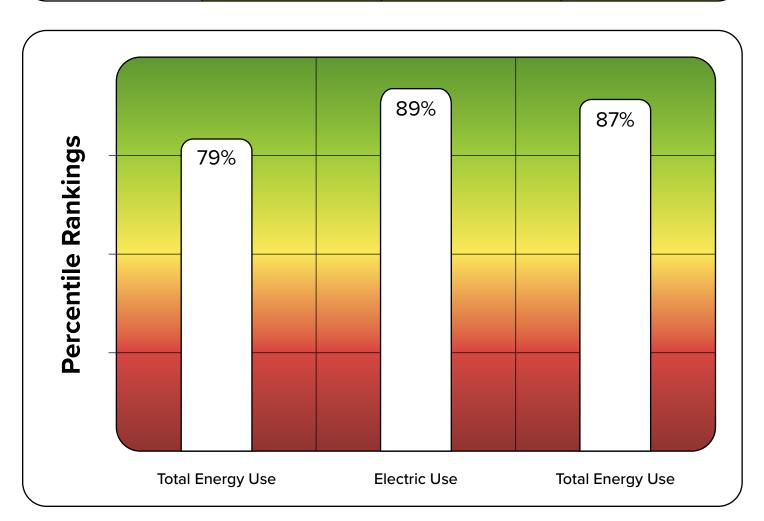
The following benchmarking analysis compares the Erin School District to an average school district in Wisconsin. The District uses less electricity per square foot than the average school district in Wisconsin.

Erin School District • Benchmarking			
	Total Energy Use kBu/ft²	Electric Use kWh/ft²	Total Energy Cost \$/ft²
Average School District	70.48	6.2	\$0.78
Erin School District	51.8	3.5	\$0.73
Percentile Rankings	79%	89%	87%

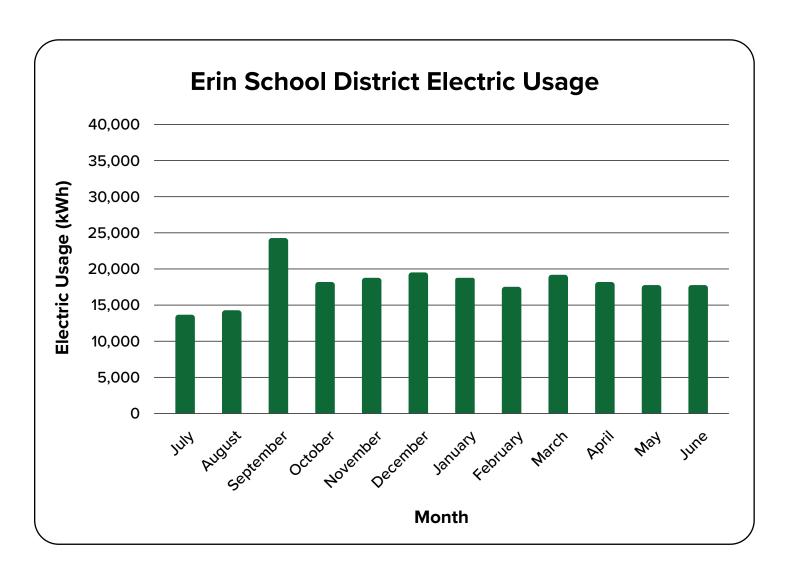
The utility graph below demonstrates the electrical consumption at the Erin School District from July 2023 through June 2024. This consumption stays relatively consistent, due to year-round use.

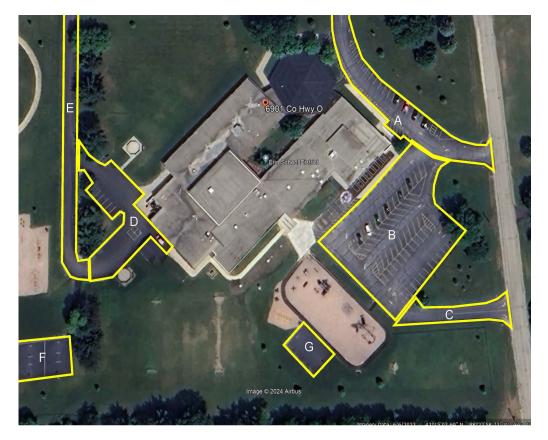
Detail Description	Size (Sq Ft)	Asphalt Replacment				Maintenance Cost Estimate													
Asphalt Area			Need Ranking	Install	Age	Plan Rplmt	Cost Estimate	Replace	Overlay	IFill &	Restripe - Paint	Notes								
А	Northeast Drive & Parking	15500	2	2010	14	2025		\$93,000	\$62,000	\$4,650	\$1,550	2024 Crack filled, sealed, and painted.								
В	Main Parking Lot	30000	1	2010	14	2026		\$180,000	\$120,000	\$9,000	\$3,000	2024 Crack filled, sealed, and painted.								
С	Southeast Drive Entry to Main Parking	4000	3	2015	9	2027		\$24,000	\$16,000	\$1,200	\$400	2024 Crack filled, sealed, and painted.								
D	Southwest Service Areas	11000	4	2022	2	2033		\$66,000	\$44,000	\$3,300	\$1,100	2024 Crack filled, sealed, and painted.								
Е	West Drive	11200	5	2022	2	2033		\$67,200	\$44,800	\$3,360	\$1,120	2024 Crack filled, sealed, and painted.								
F	West Play Lot	4000	5	2021	3	2033		\$24,000	\$16,000	\$1,200	\$400	2024 Crack filled, sealed, and painted.

Replace	\$6.00	w additional base
Overlay	\$4.00	
Crack Fill	\$0.30	
Seal	\$0.30	
Paint	\$0.10	
Patch	\$200	Each - Infrared Heat Patch (approx. 5' x 7')

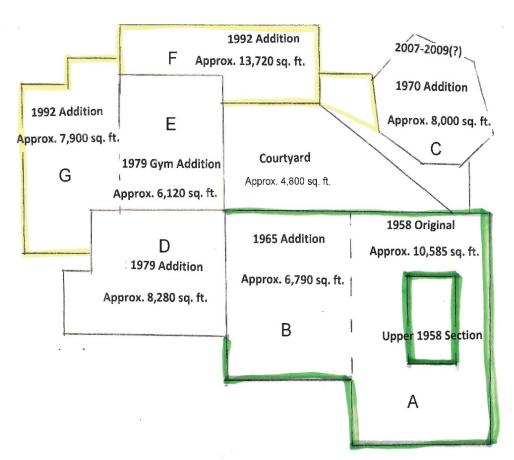
Roof	Datail Description	Sizo (Sa. ET)	Need	R	oof	Plan	Cost	
Section	Detail Description	Size (Sq. FT)	Ranking	Install	Age	Rplcmt.	E	stimate
Α	1958 Original Building including Upper Section	10585	4	2019	5	2039	\$	105,850
В	1965 Addition	6790	4	2019	5	2039	\$	67,900
С	1970 Addition including perimeter corridors	8000	1*	2008	16	2028	\$	80,000
D	1979 Addition (Non-Gym)	8280	3	2010	14	2030	\$	82,800
Ε	1979 Addition (Gym)	6120	3	2010	14	2030	\$	37,750
F	1992 Addition (MS Classrooms)	13720	5	2023	1	2043	\$	137,200
G	1992 Addition (Café, Band, Special Ed)	7900	5	2023	1	2043	\$	79,000
